## INDUSTRIAL AREAS

### **Fairmont Avenue**

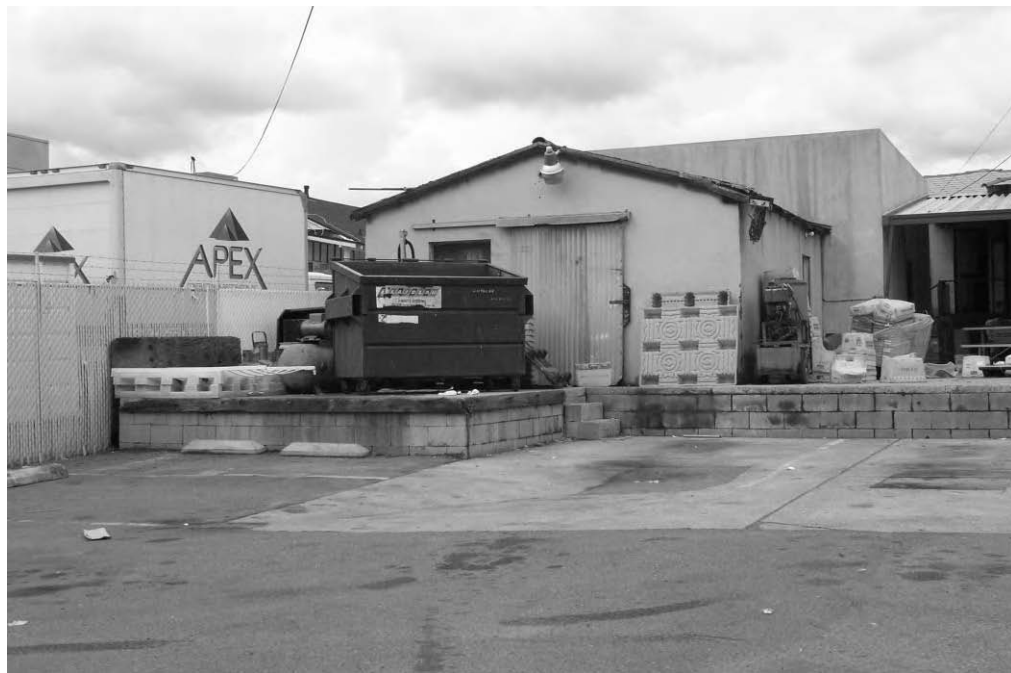
**Parcel Number – 458 522 04**

This property is suffering from physical deterioration due to lack of maintenance and excessive use. The single-family has been converted to a distributions center for a courier service through a series of substandard and poorly maintained additions.

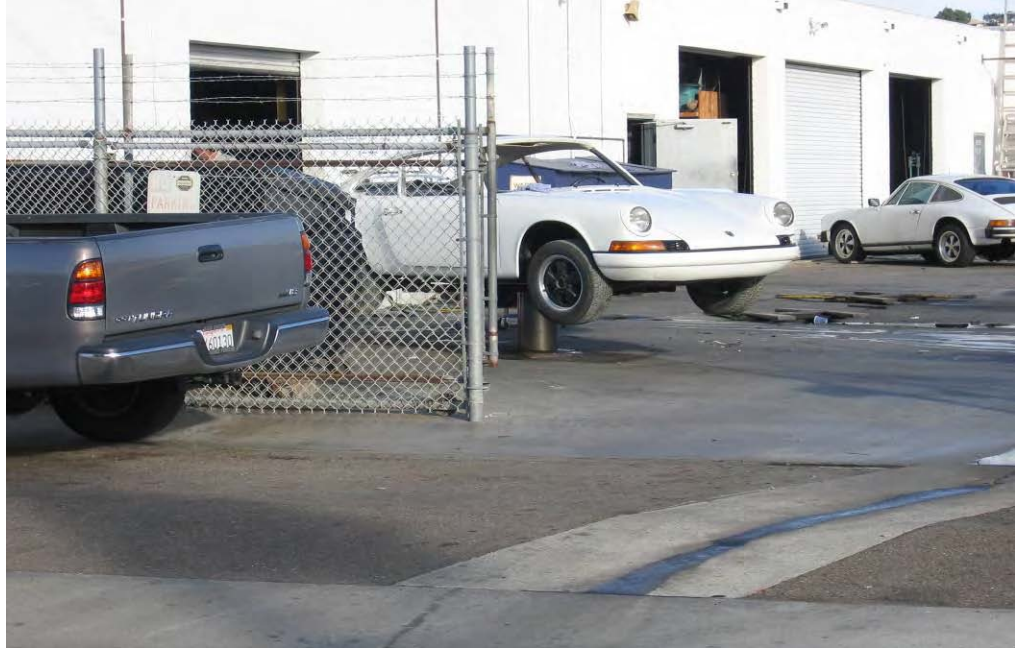
**Parcel Number – 461 160 05**

This auto repair shop on Fairmont Avenue is typical of many auto repair businesses in the Project Area that have limited building space and must resort to outdoor repairs. Also, as with most properties, runoff from site is draining directly into the street and left untreated to drain into the San Diego River.

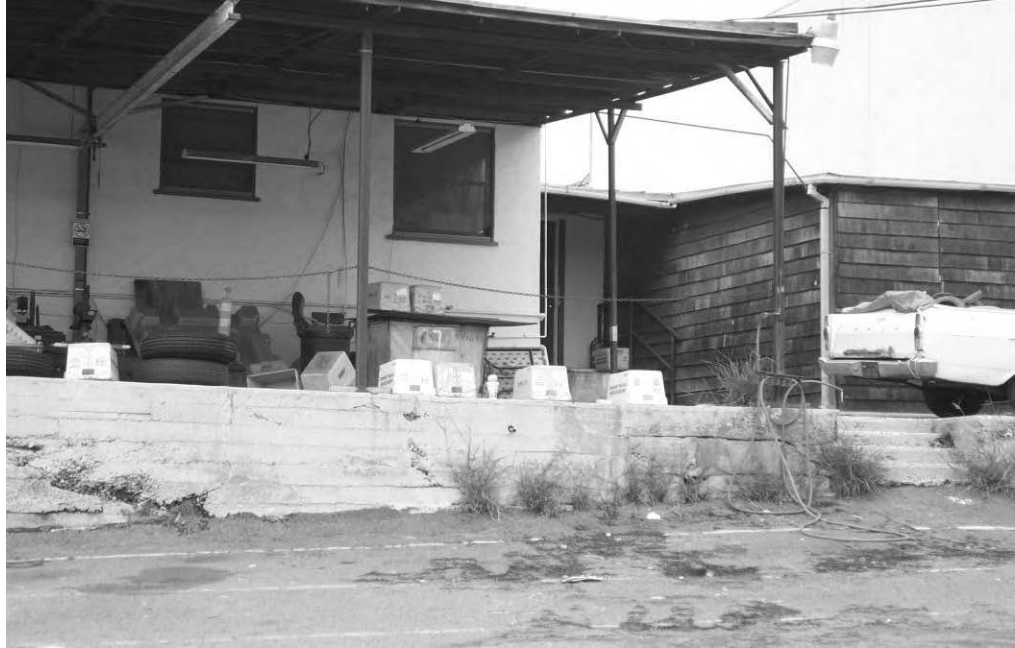
**Parcel Number – 458 522 06**

This single-family residential structure also suffers from incompatible industrial uses, substandard and deteriorating additions as well as a lack of storage area for trash and debris.

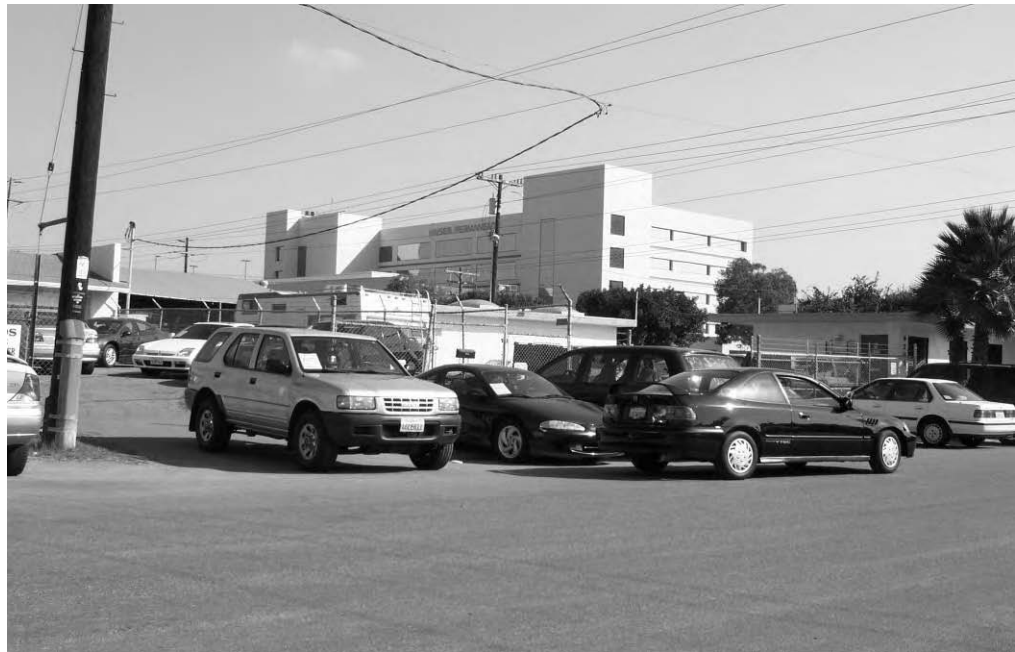
**Parcel Number – 458 510 14**

Lack of off-street parking, caused vehicles to be double parked in the public right-of-way creating an unsafe access and egress to the properties for cars and pedestrians.

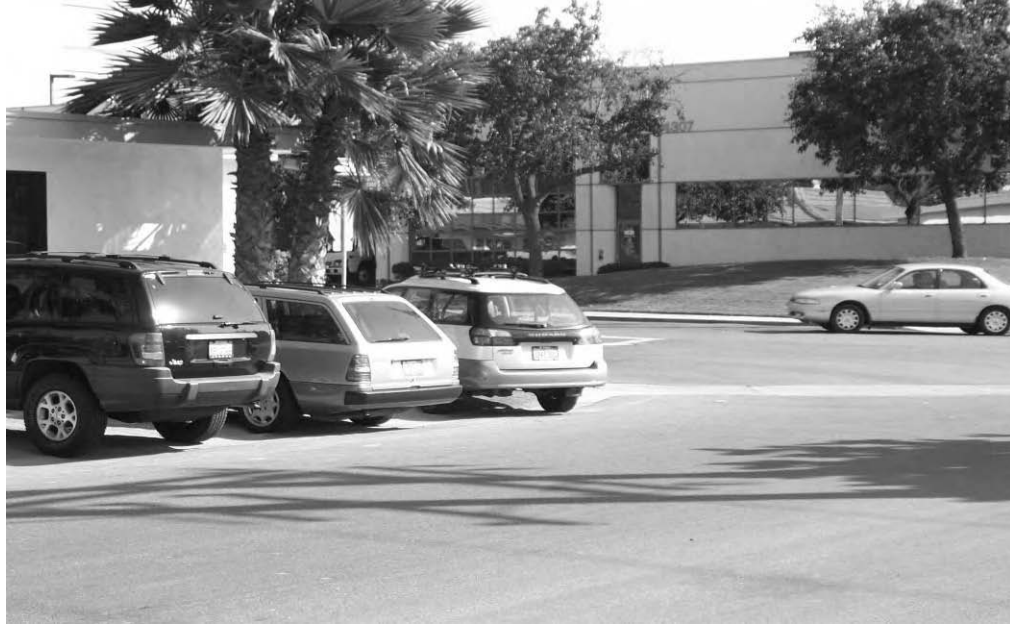
**Parcel Number – 458 510 30**

Lack of on-site parking, causing vehicles to park in the public right-of-way creating an unsafe traffic condition by restricting traffic view sight lines for vehicles and pedestrians.

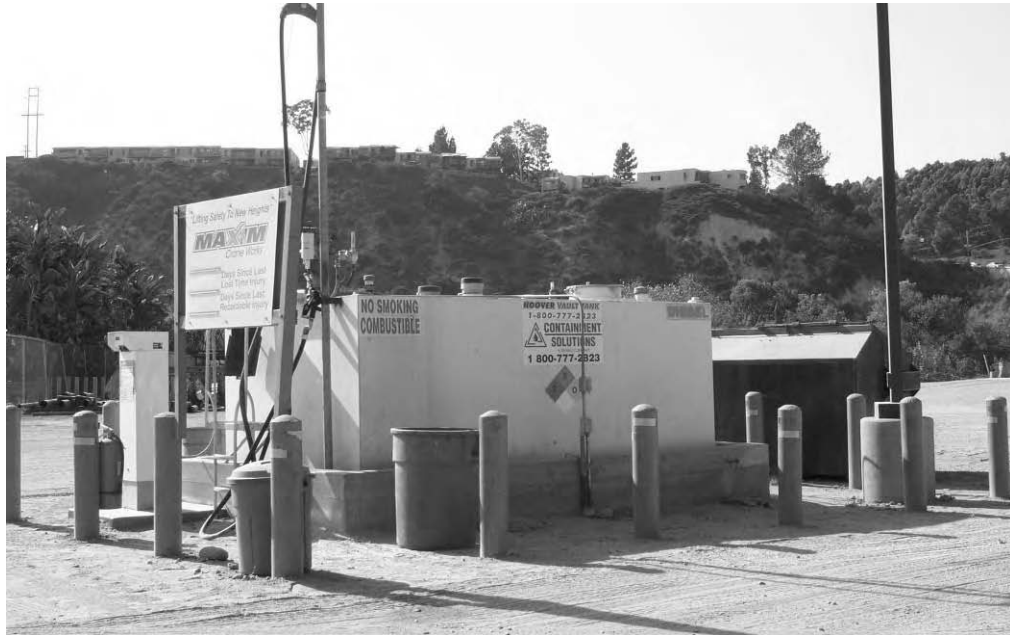
**Parcel Number – 458 300 03**

Outdoor refueling area on dirt lot next to San Diego River. Outdoor welding and storage of heavy equipment takes place at this site with runoff from welding debris, rusting equipment and refueling operations draining directly into the San Diego River or leaching into the soil and groundwater.

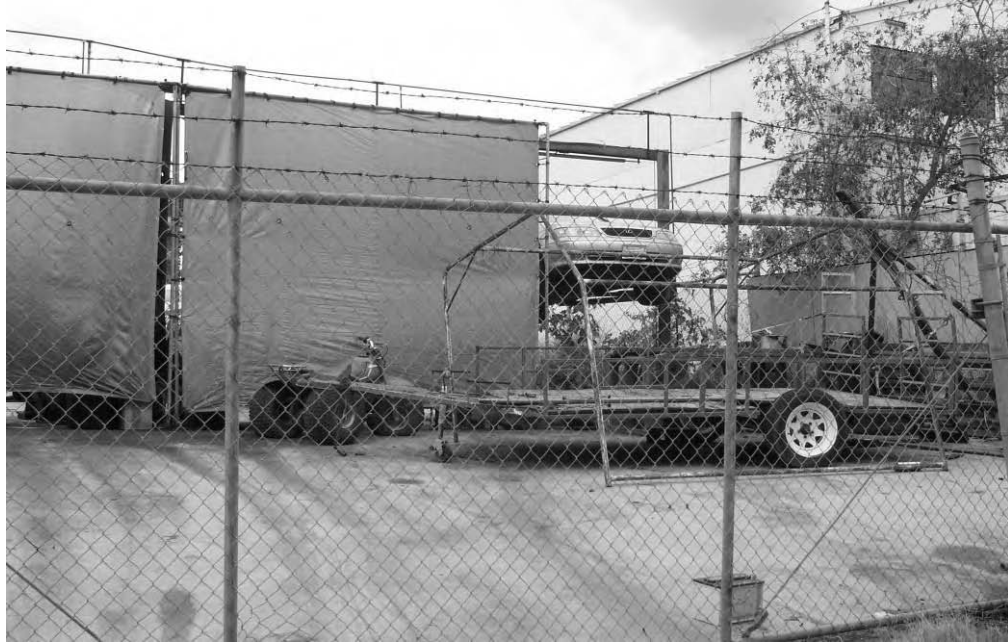
**Parcel Number – 458 521 25**

Outdoor vehicle repair area with industrial runoff including motor oil, transmission fluid and battery acid. Left-over parts from repairs (batteries engines blocks) are a significant source of contamination in the Project Area.

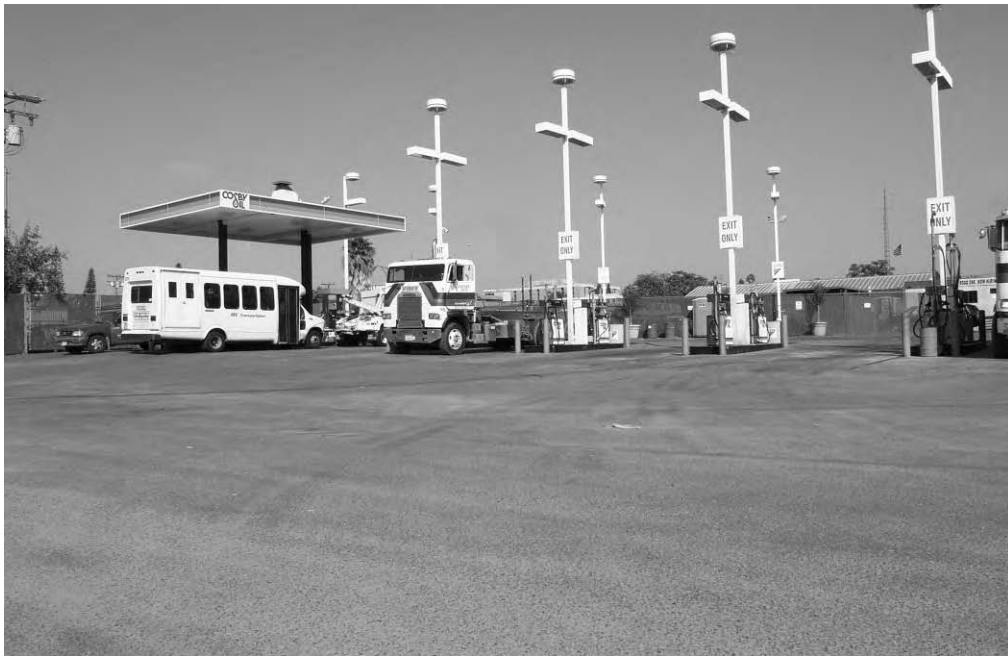
**Parcel Number – 458-510-03**

Gas station for commercial vehicles, which drains runoff directly into the San Diego River and takes access off side streets and alleys, negatively affecting surrounding traffic circulation as large vehicles travel these smaller streets.

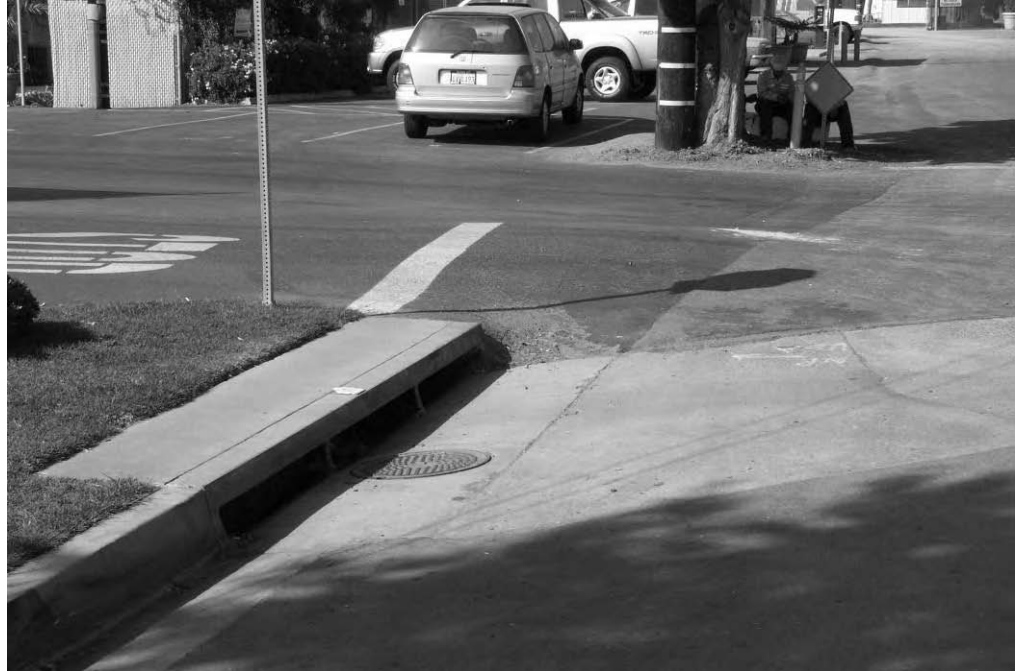
**Parcel Number – 458 150 10**

Storm drains serving most of the Fairmont industrial area capture runoff and send it directly (untreated) into the San Diego River.

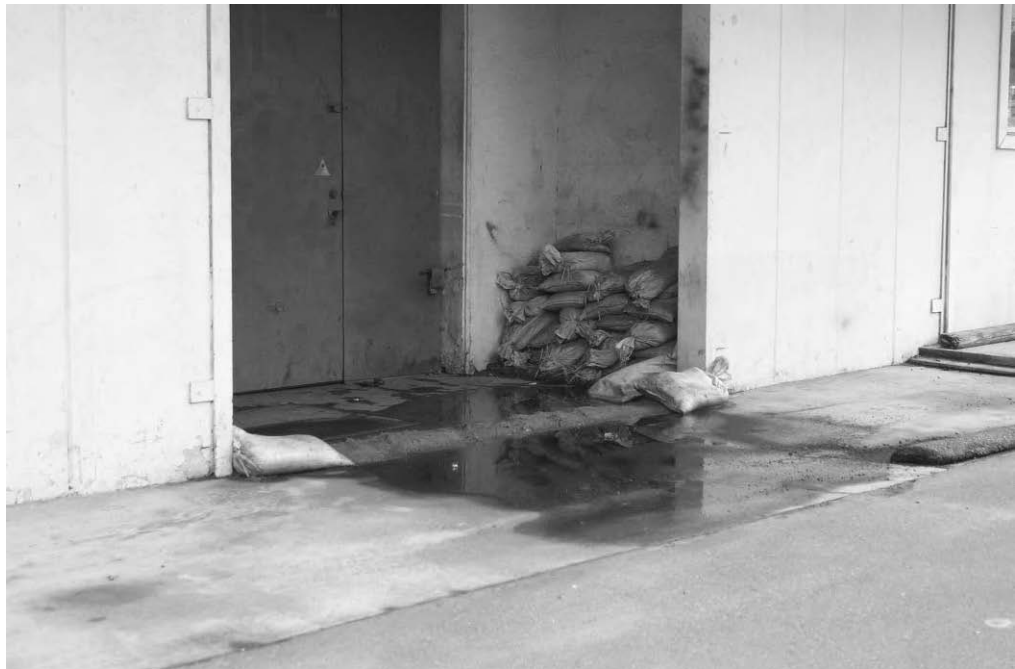
**Parcel Number – 461-220-12**

Area is prone to flooding and suffer from stagnant water after a storm.

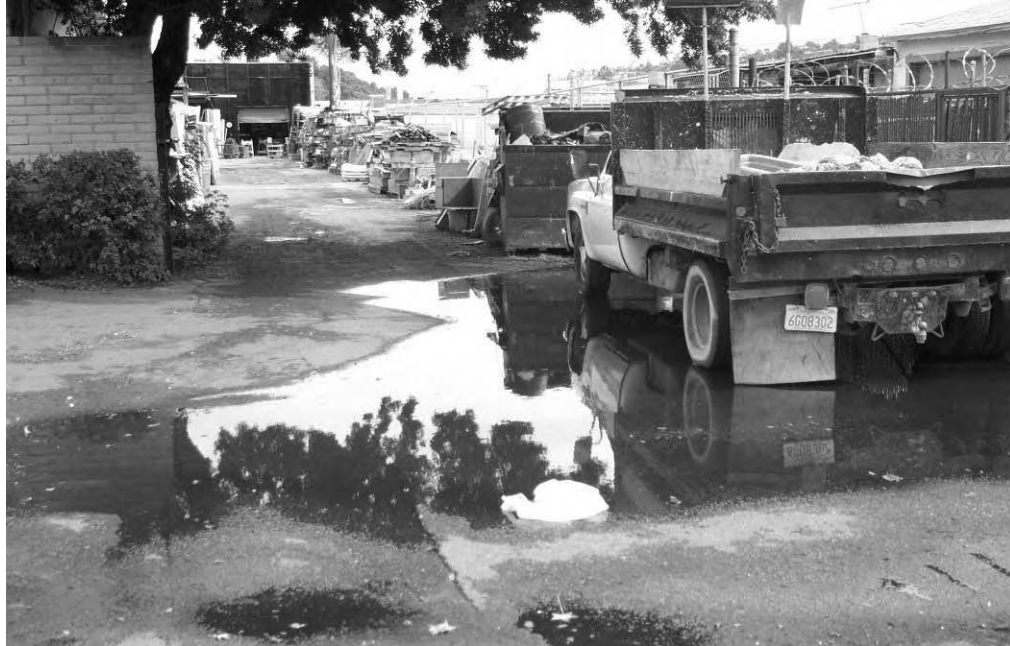
**Parcel Number – 461 160 01**

Excessive lot coverage and unsafe storage of flammable materials in crowded conditions.

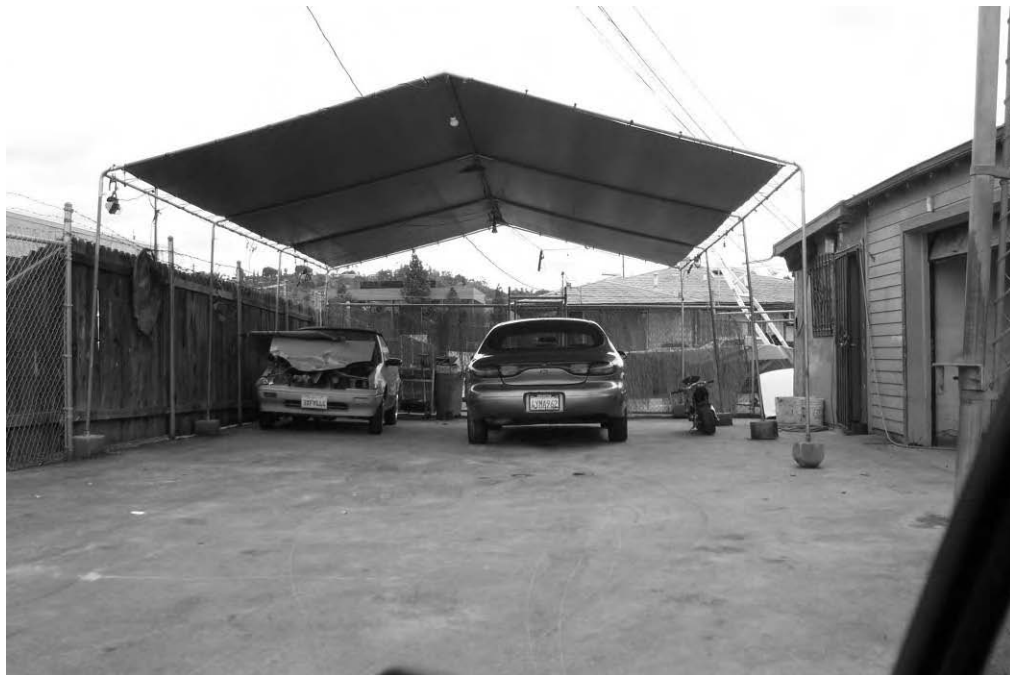
**Parcel Number – 458 521 11**

Outdoor auto body repair using canvas canopies without proper air ventilation equipment for painting in a residential structure converted to industrial use.

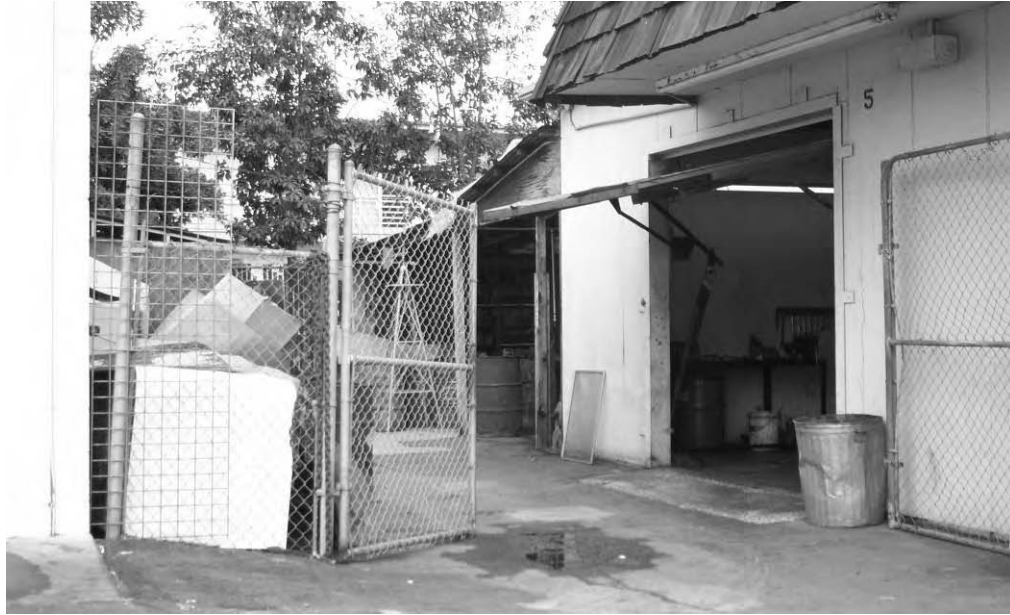
**Parcel Number – 461 220 12**

Poorly constructed addition with use of flammable materials in a confined working area.

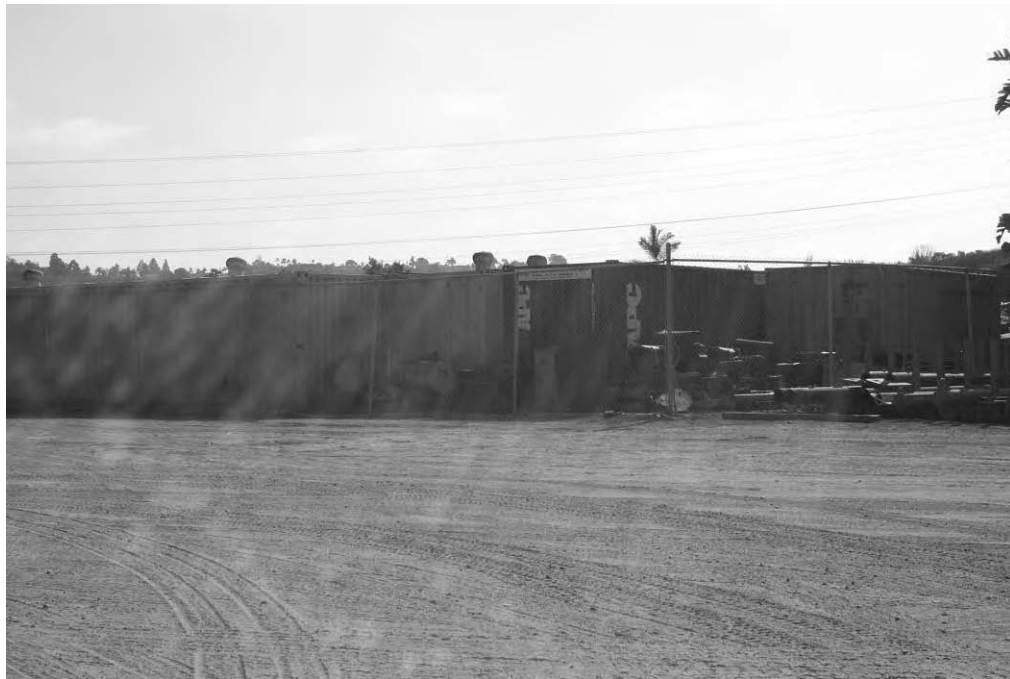
**Parcel Number – 458 300 04**

Container storage units with ventilation fans and unpermitted electrical service have been converted to substandard work areas.

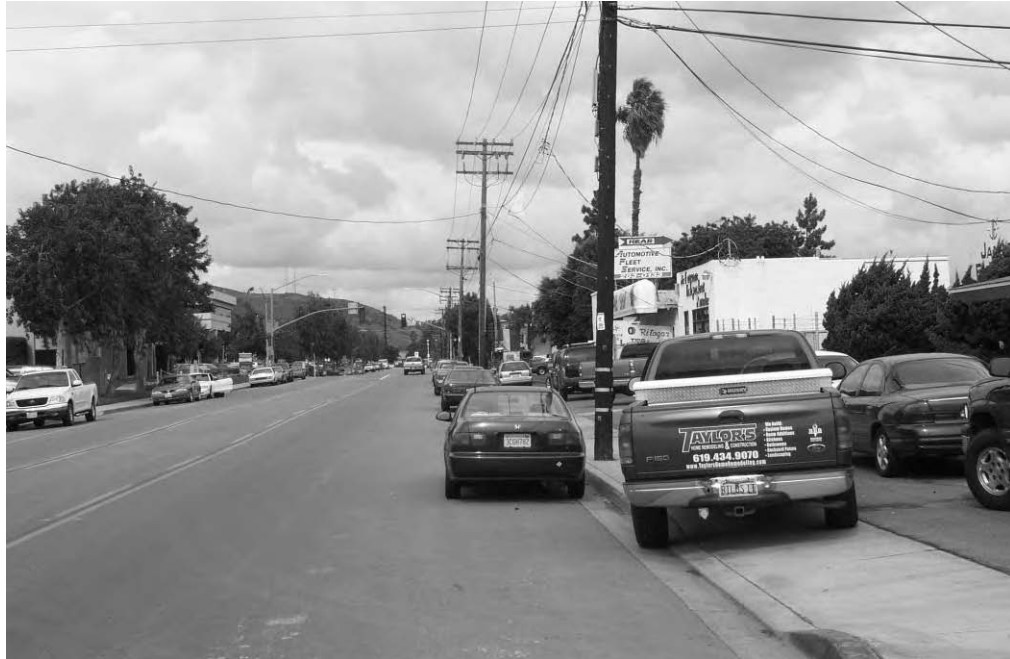
#### **Parcel Number – 461 160 05**

Multiple curb cuts servicing narrow parcels reduce on street parking. Inadequate parking is also negatively impacted by older site design where buildings were not set back adequately from the street. The result is unsafe vehicle and pedestrian traffic conditions. Also, the visual appearance is compromised by the large number of utility poles servicing the overall Project Area.

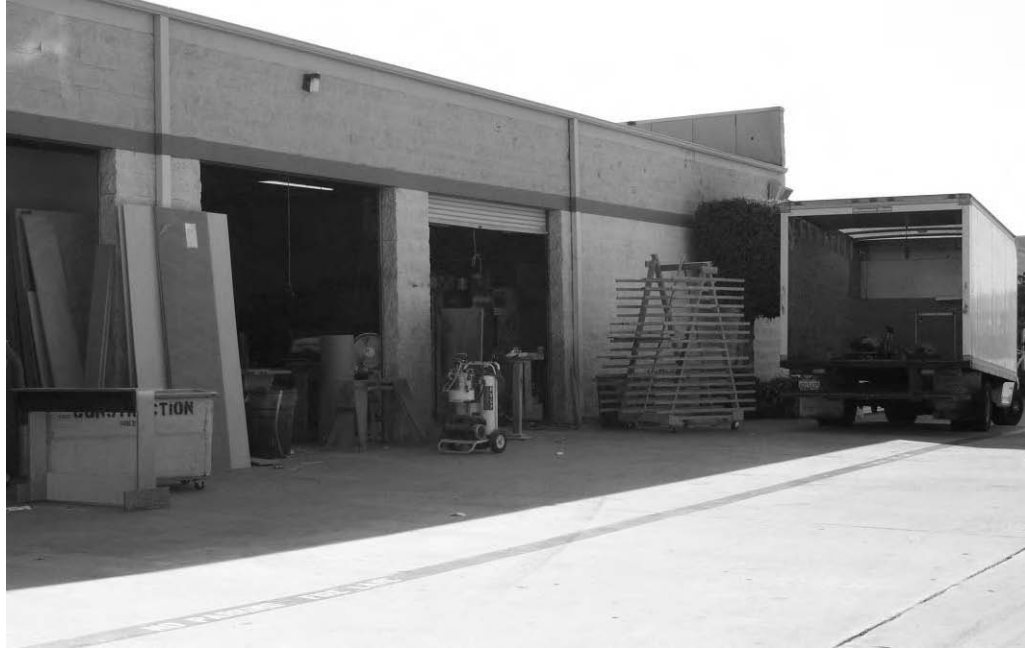
**Parcel Number – 461 330 33**

Outdoor manufacturing and storage near a fire lane. Occupant's floor space is not large enough to accommodate manufacturing activities. Due to low vacancy rates it will be difficult for occupant to relocate to larger facility.

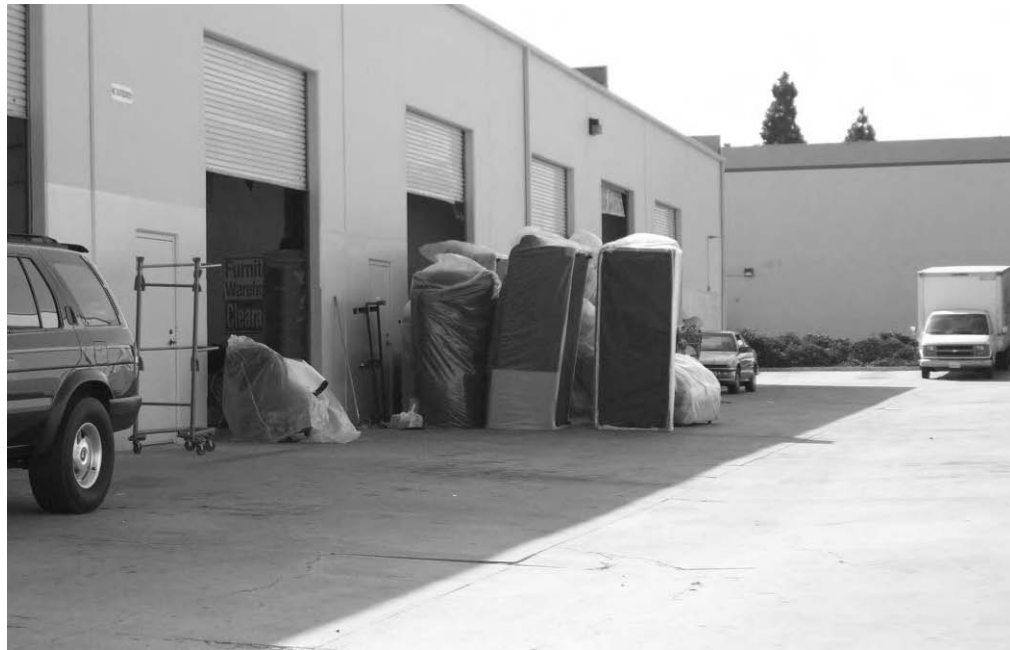
**Parcel Number – 461 620 05**

Many industrial occupants store material outside while conducting manufacturing activities inside the building. This situation makes production more complicated and leaves an unsightly appearance.

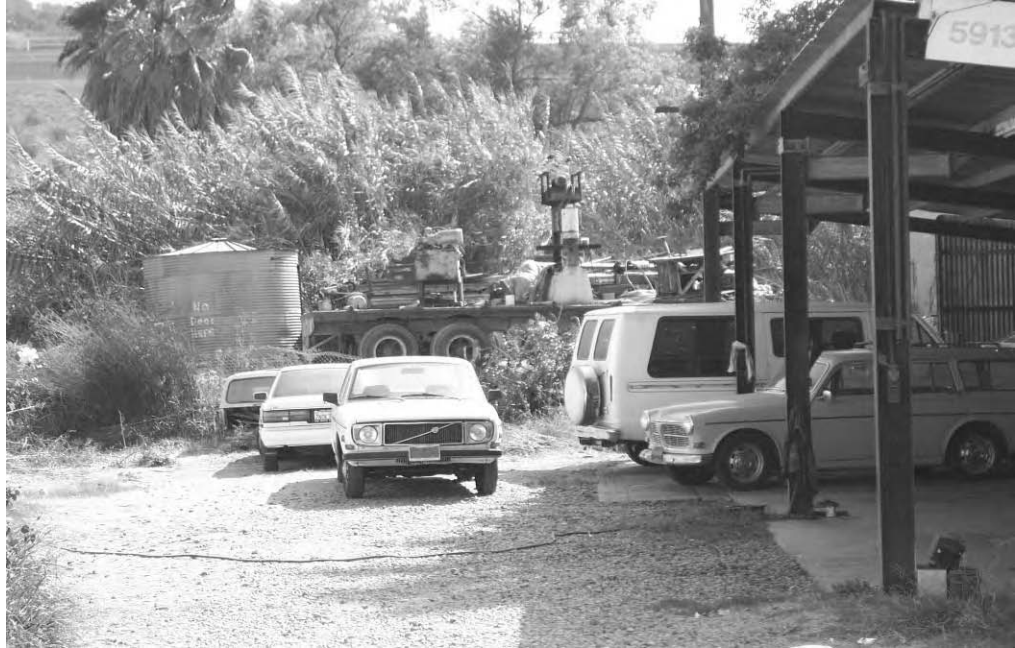
**Parcel Number – 461 320 11**

Outdoor vehicle repair with storage of salvaged vehicles and machinery on a dirt lot next to Alvarado Creek where site runoff drains to.

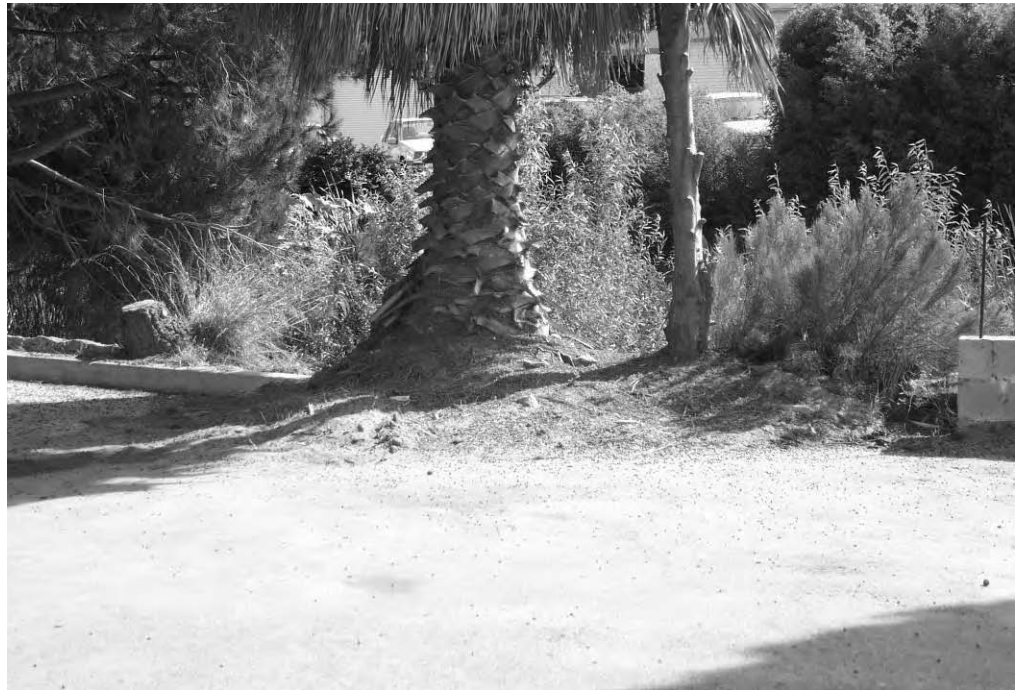
**Parcel Number – 461 210 05**

Most of Mission Gorge Place is subject to flooding conditions. This property shows where Alvarado Creek has overflowed its bank and left soil deposits on the property.

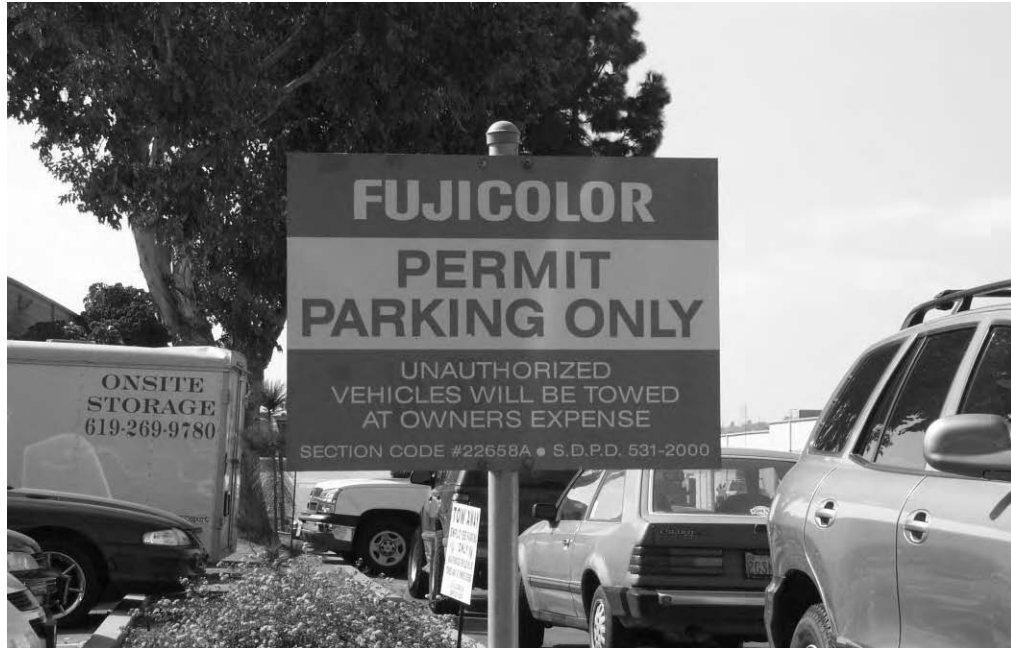
**Parcel Number – 461 330 21**

Inadequate on-site parking for neighboring properties requires permit parking to be instituted.

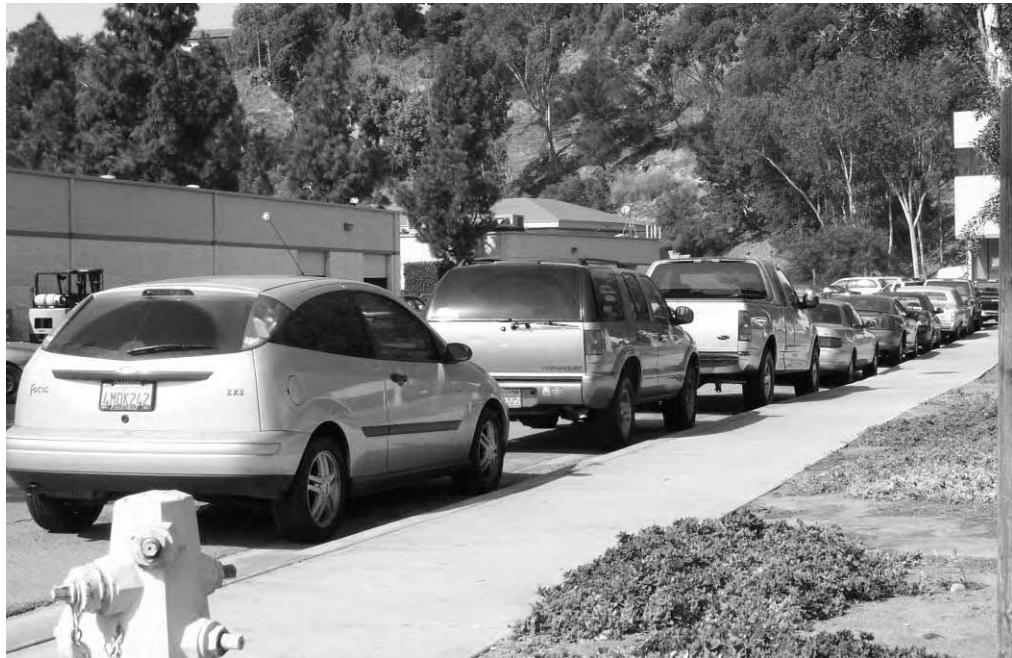
**Parcel Number – 461 620 07**

Lack of on-site parking leads to overcrowded on-street parking, this causes unsafe traffic conditions due to lack of visibility for vehicles accessing Mission Gorge Place from the Post Office.

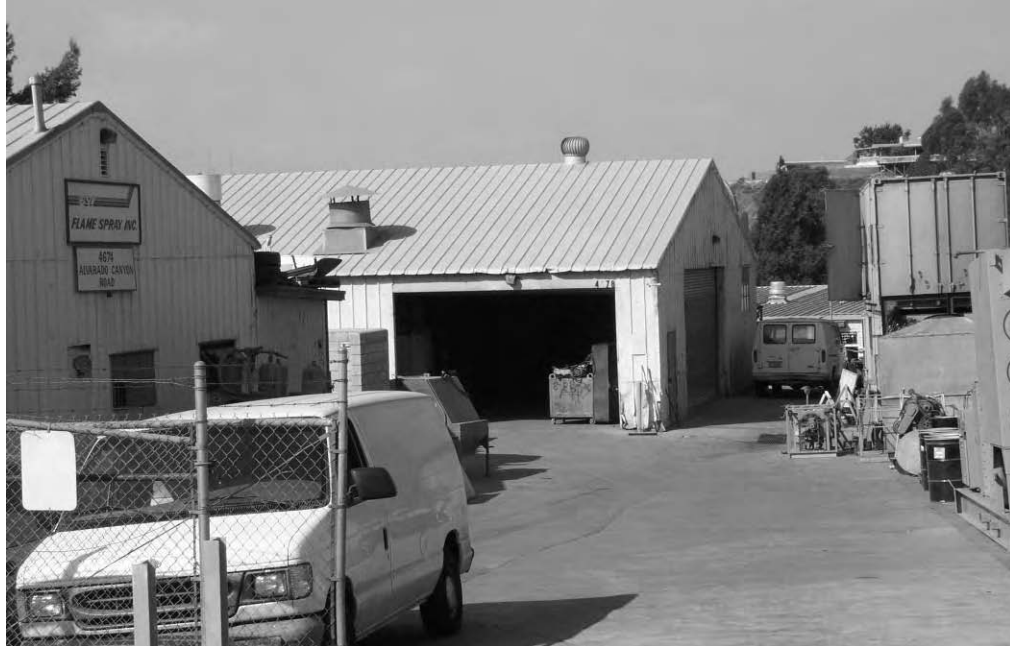
**Parcel Number – 461 330 32**

This property and several others along in the Mission Gorge Place industrial area use substandard metal building materials in a confined manufacturing area.

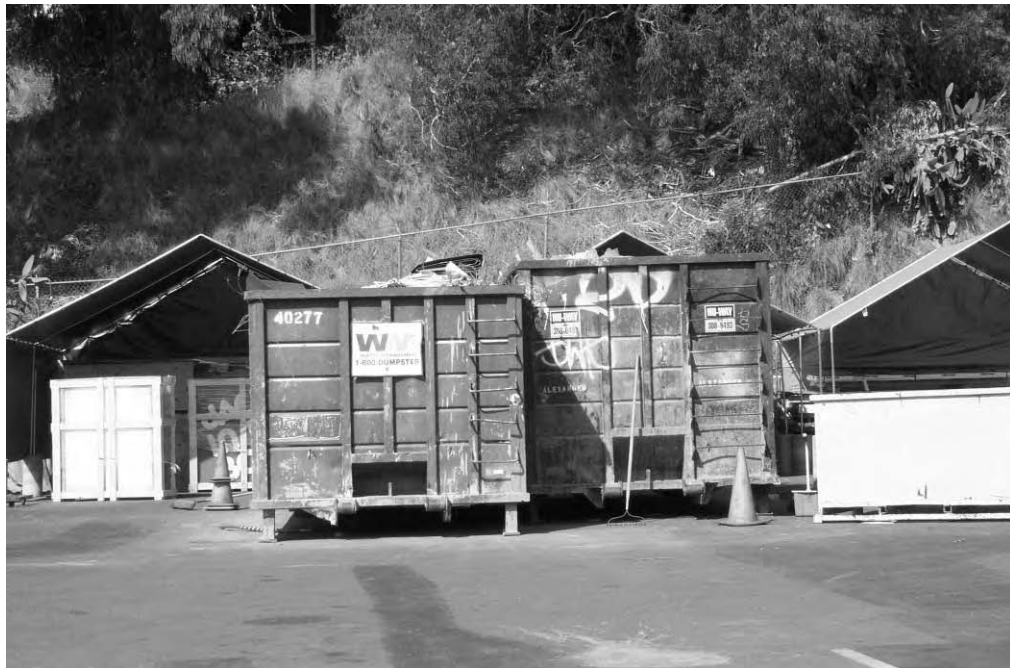
**Parcel Number – 461 330 23**

This site uses substandard and unsightly canopies for outdoor manufacturing and storage.
